# Manhole Inspection Summary

Manhole # S13CC2051MH

**Location** Address: **5707 CROSS COUNTRY BLVD**

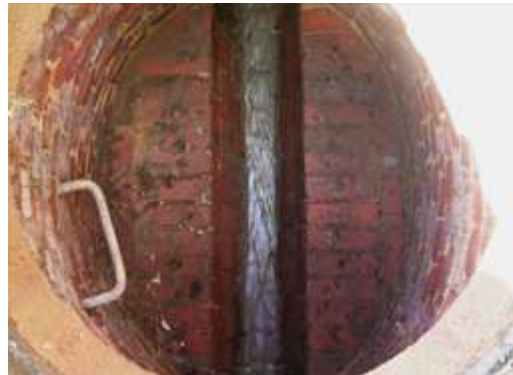
Top View

**Bench** ☒ Exists Material: **Brick** ☐ Parged ☒ **Debris** (not Condition related)

**Surcharge** ☒ **Evidence Of Surcharge** Depth: **1** (ft.) ☐ Active Surcharge Present

Evidence of surcharge - Bench debris.

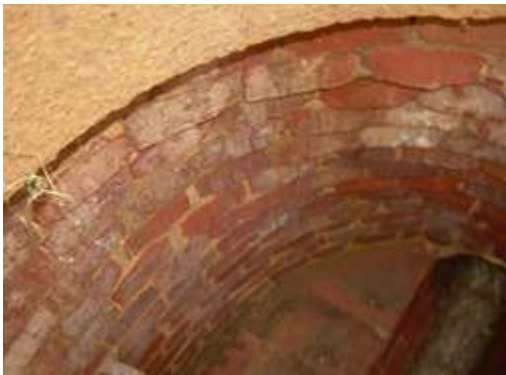
Defect

**Frame** Offset: **0** (in.) Condition: ☐ Sound ☐ Cracked ☒ **Leaks**

Infiltration: ☐ None ☒ **Joint** ☐ Cracks ☒ **Mortar** ☐ Roots ☐ Wall

Infiltration: ☐ None ☐ Joint ☐ Cracks ☒ **Mortar** ☐ Roots ☒ **Wall**

Frame leaks. Corbel and Barrel infiltration.

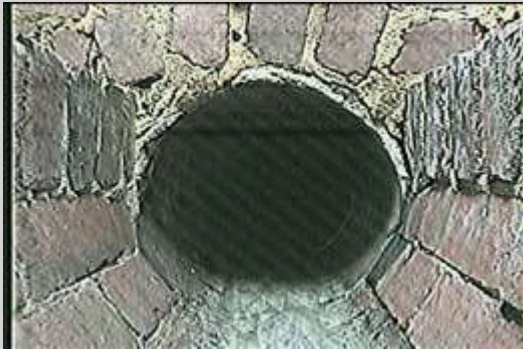
### 10 in. Circular Gravity Sewer Pipe Out @ 12 O'Clock

Infiltration: **None** Pipe Seal Cond: **Cracked**

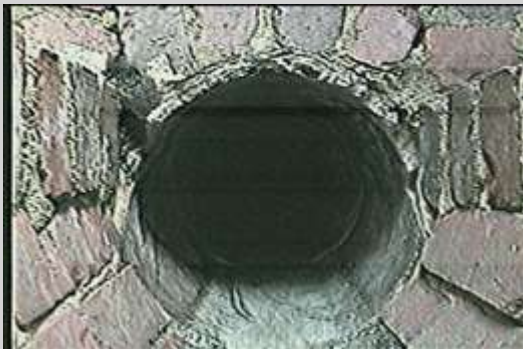
### 10 in. Circular Gravity Sewer Pipe In @ 6 O'Clock

Condition: ☐ Sound ☐ Cracked ☐ Root Intrusion ☒ **Deteriorated** ☐ Leaks ☐ Debris

Channel deterioration.

Infiltration: **Evidence** Pipe Seal Cond: **Broken**
